*metallic alloys, biomaterials,
surface damage, corrosion*

Anita KRAUZE, Wojciech KAJZER,
Józef DZIELICKI, Jan MARCINIAK

INFLUENCE OF MECHANICAL DAMAGE ON CORROSION RESISTANCE OF PLATES USED IN FUNNEL CHEST TREATMENT

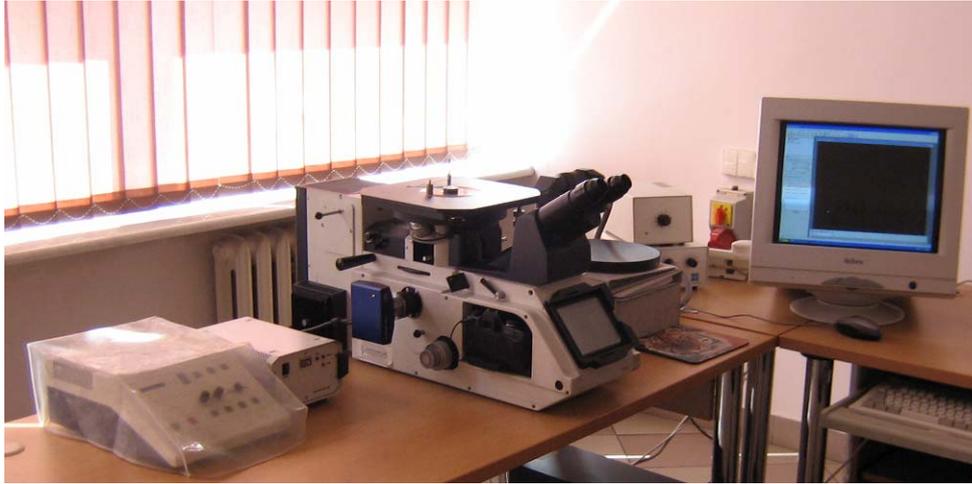
Fig. 5. The MEFLA (LEICA) light microscope

The first stage of research 50 plates after implantation was selected. All the plates were made of the AISI 316 LVM stainless steel. The chemical composition meets the PN ISO 5832-1 standard [17]. In order to check the amount of non-metallic inclusions and grain size, additional metallographic and microscopic tests were carried out with the use of the MEFCA (LEICA) light microscope – Fig. 5.
